Manhole Inspection Summary

Manhole # S47AA_044MH

Insp Date: **6/20/08 1:25 PM**

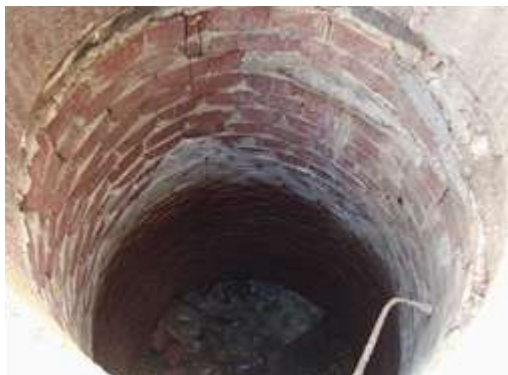
Defect 1

Infiltration: ☐ None ☒ **Joint** ☐ Cracks ☒ **Mortar** ☐ Roots ☒ **Wall**

infiltration

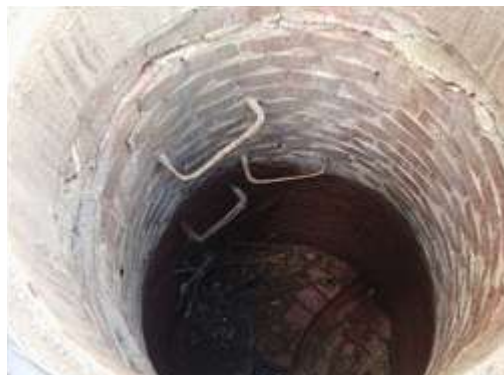
Defect 2

Condition: ☐ Sound ☐ Cracked ☐ Root Intrusion ☒ **Loose Brick** ☐ Deteriorated

deterioration

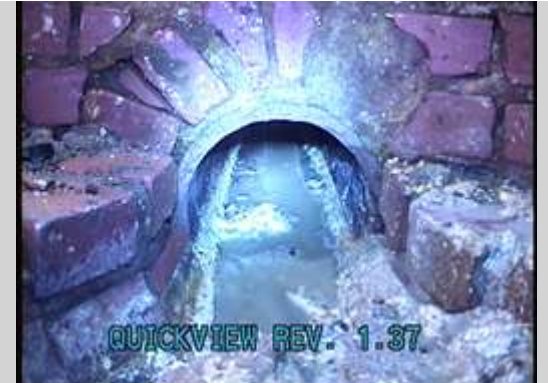
12 O'Clock Outflow

8 in. Circular Gravity Sewer
Pipe Out @ 12 O'Clock

Pipe Height: **8.4** (in.) Rod and Bar (Angled)
Pipe Material: **Clay** ☐ Pipe Lined
Invert Depth: **9.90** (ft.) Flow Characteristics: **None**
Deposits: ☒ None ☐ Mud ☐ Sludge ☐ Debris ☐ Grease
Silt Depth: (in.) Deposits Extent:
Infiltration: **None** Pipe Seal Cond: **Sound**

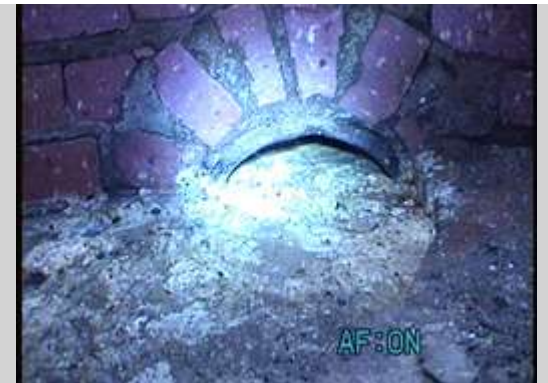
3 O'Clock Inflow

8 in. Circular Gravity Sewer
Pipe In @ 3 O'Clock

Pipe Height: **8.4** (in.) Rod and Bar (Angled)
Pipe Material: **Clay** ☐ Pipe Lined
Invert Depth: **9.85** (ft.) Flow Characteristics: **None**
Deposits: ☒ None ☐ Mud ☐ Sludge ☐ Debris ☐ Grease
Silt Depth: (in.) Deposits Extent:
Infiltration: **None** Pipe Seal Cond: **Sound**

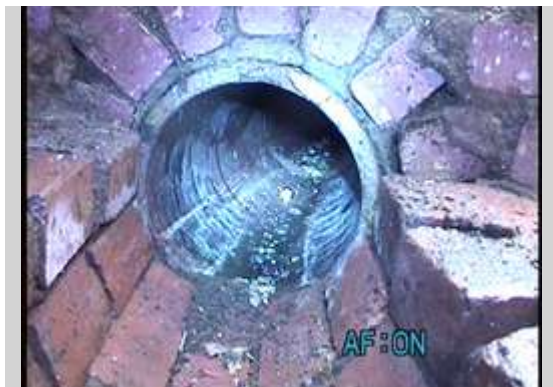
9 O'Clock Inflow

Pipe In @ 9 O'Clock

Infiltration: **None** Pipe Seal Cond: **Sound**
